| <b>Project Name:</b><br>Gold King Mine | <b>Site Location:</b><br>Silverton, San Juan County, Colorado | <b>Project No.</b><br>0001/1408-01 |

## PHOTOGRAPH LOG

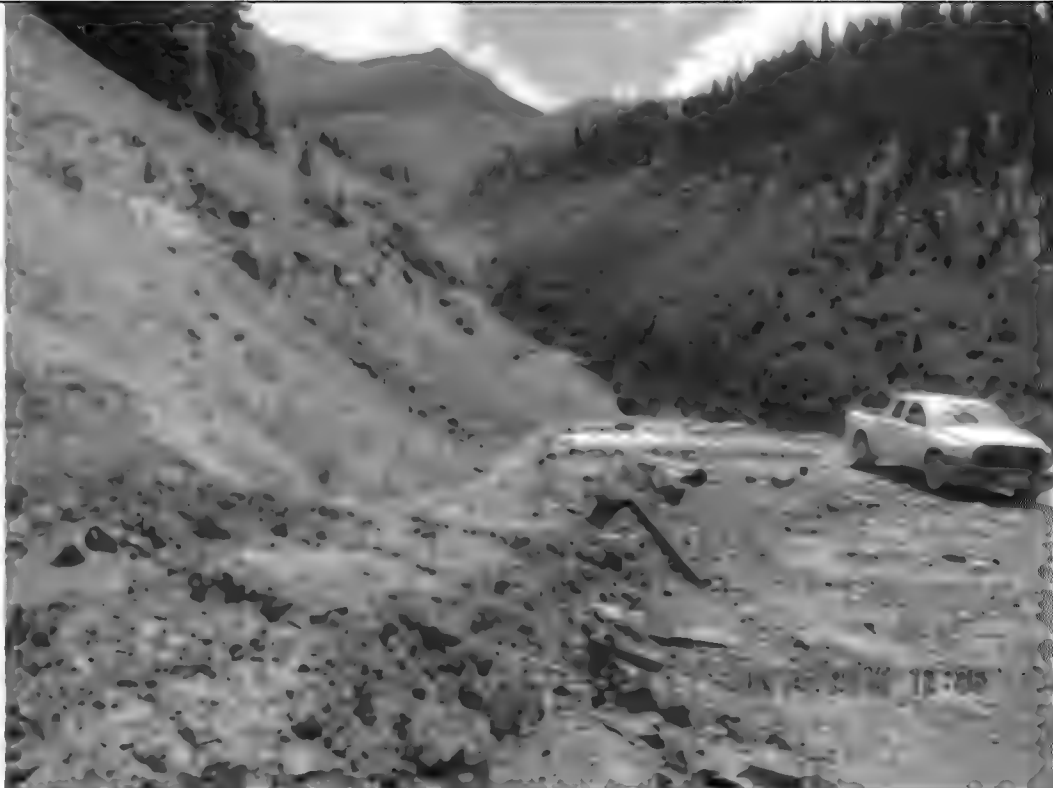
| Photo No.<br>33 | Date:<br>08/05/2015 | |

| Description:<br>Redirected flow into existing half culvert channel. | | |

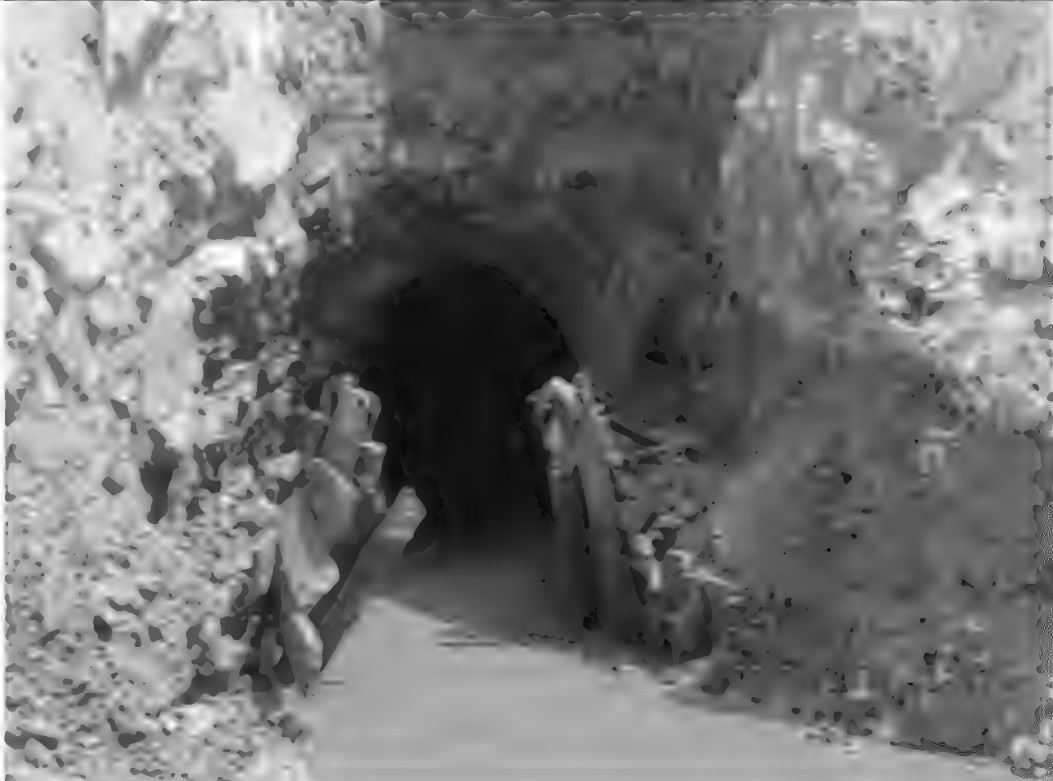
| Photo No.<br>34 | Date:<br>08/05/2015 | |

| Description:<br>Closeup of adit. | | |

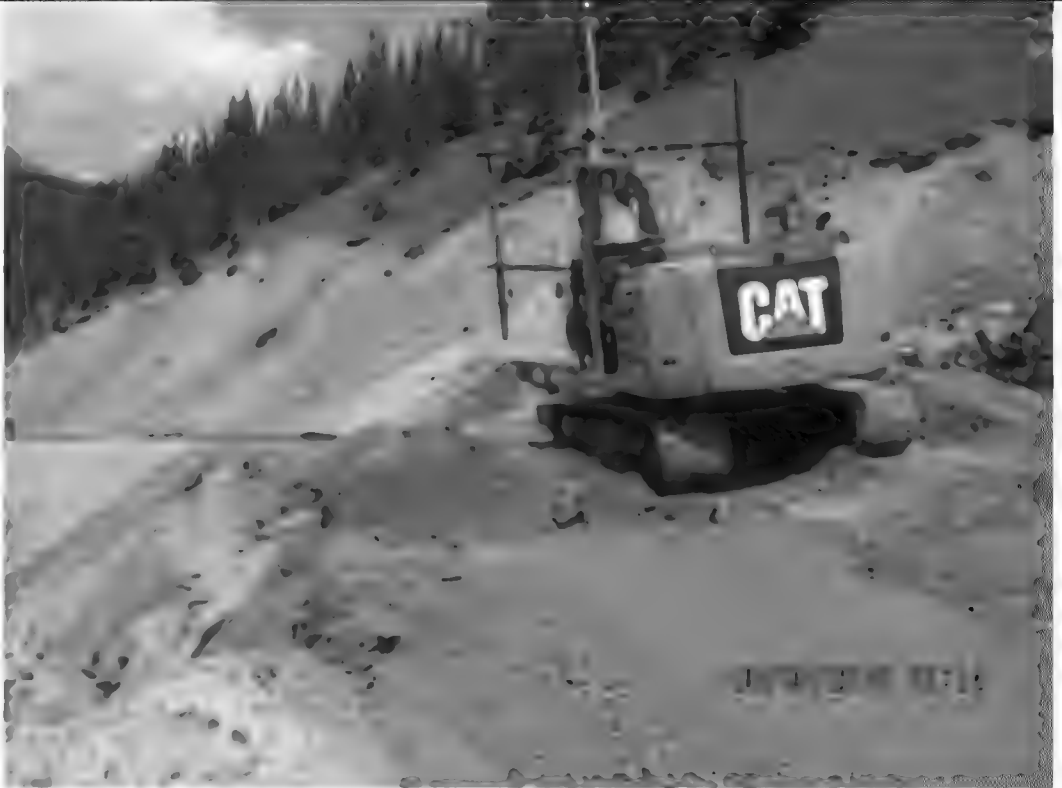
| <b>Photo No</b><br><b>35</b> | <b>Date:</b><br>08/05/2015 | |

| <b>Description:</b><br>Excavator beginning work to secure safe exit route for equipment, vehicles, and personnel. | | |

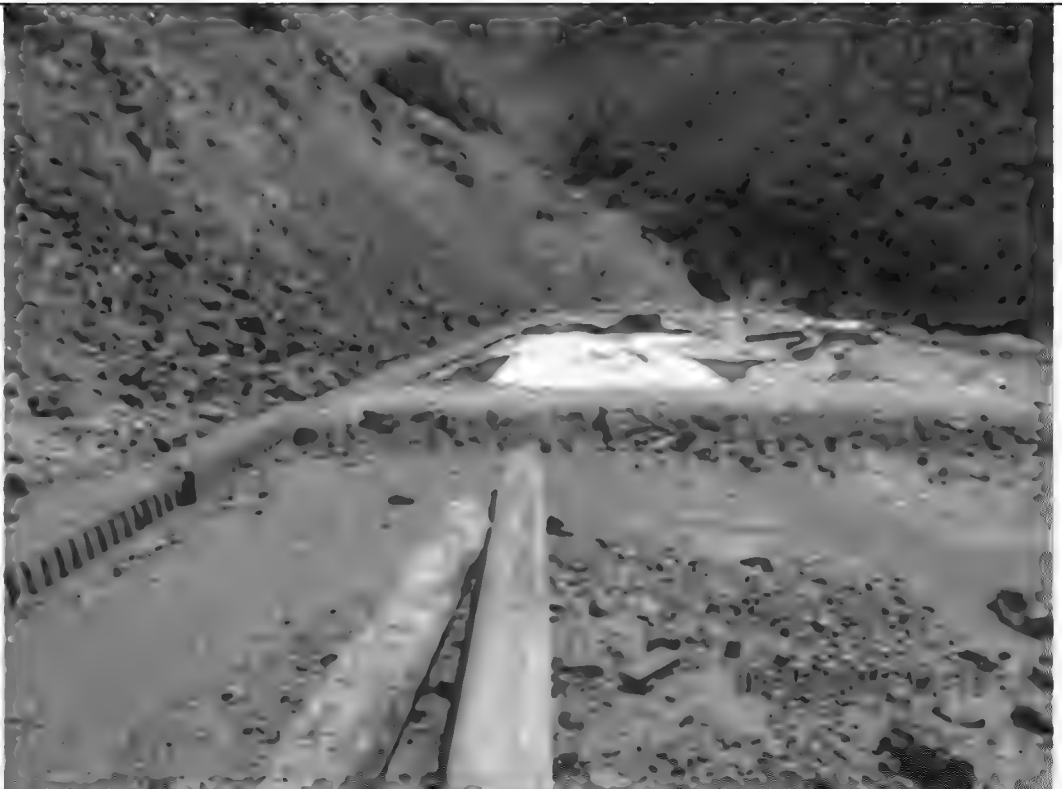
| <b>Photo No</b><br><b>36</b> | <b>Date:</b><br>08/05/2015 | |

| <b>Description:</b><br>Existing flow channel at maximum capacity | | |

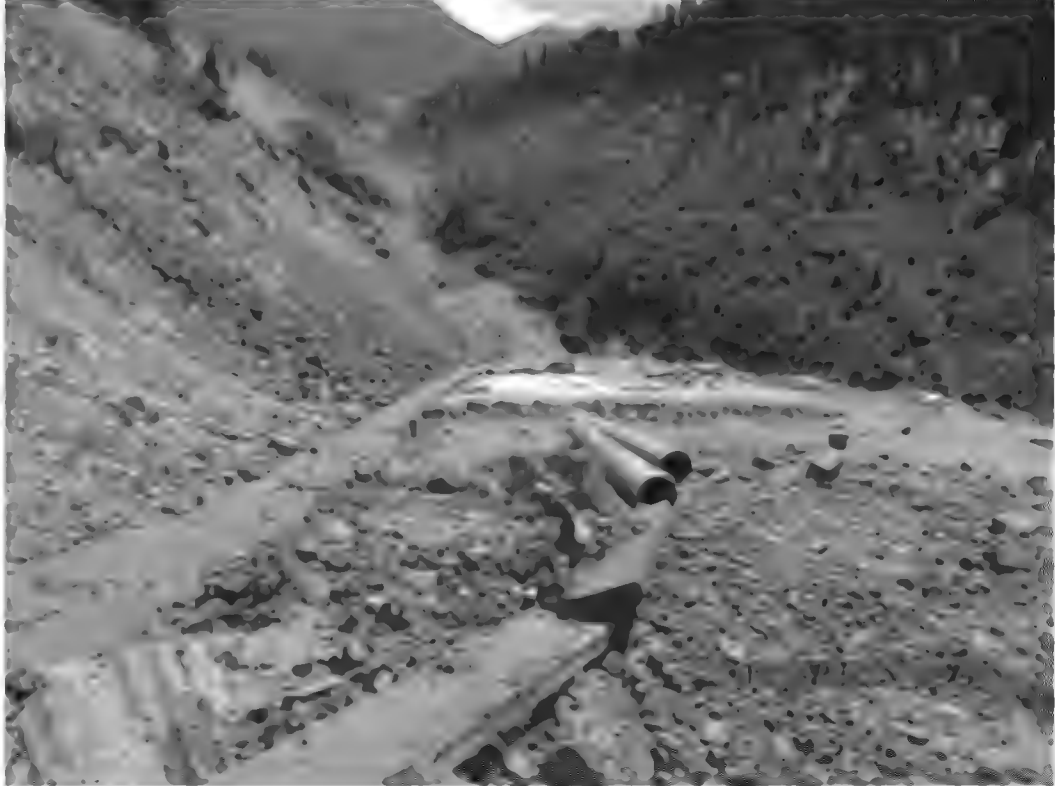
| <b>Photo No.</b><br><b>38</b> | <b>Date:</b><br>08/05/2015 | |

| <b>Description:</b><br>Existing culvert flows subsiding minimally. | | |

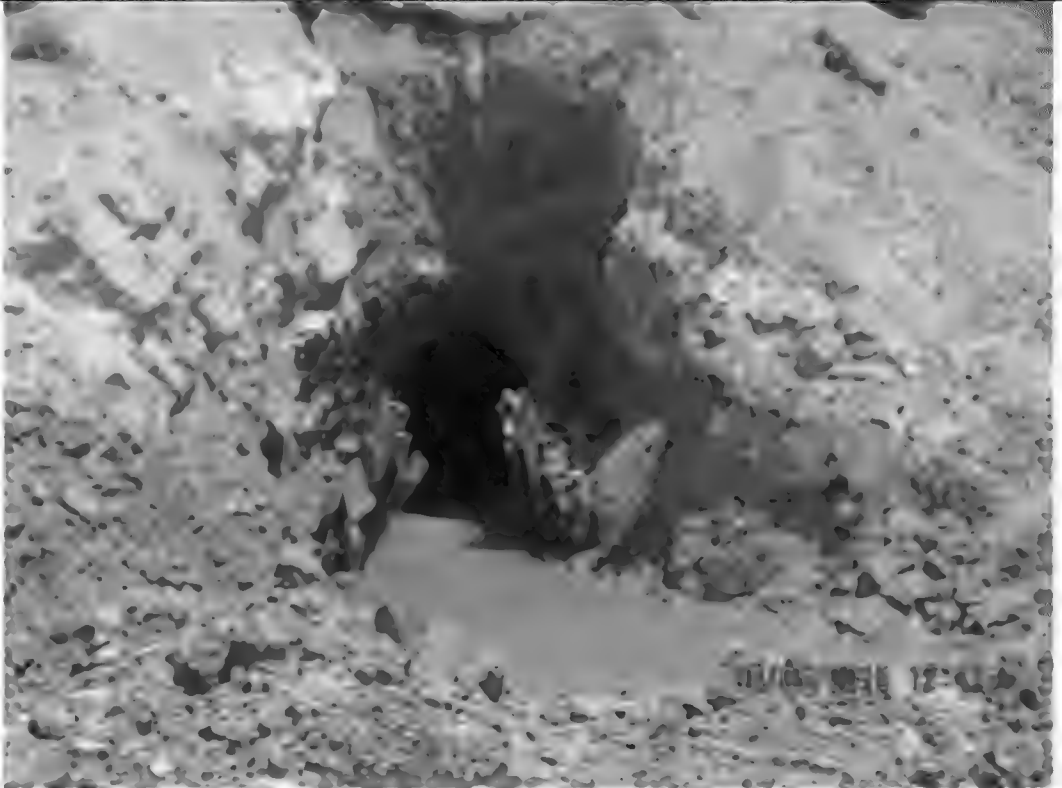
| <b>Photo No.</b><br>39 | <b>Date:</b><br>08/05/2015 | |

| <b>Description:</b><br>No changes visible in adit structure or supports. Sloughing of materials inside the mine can be heard. | | |

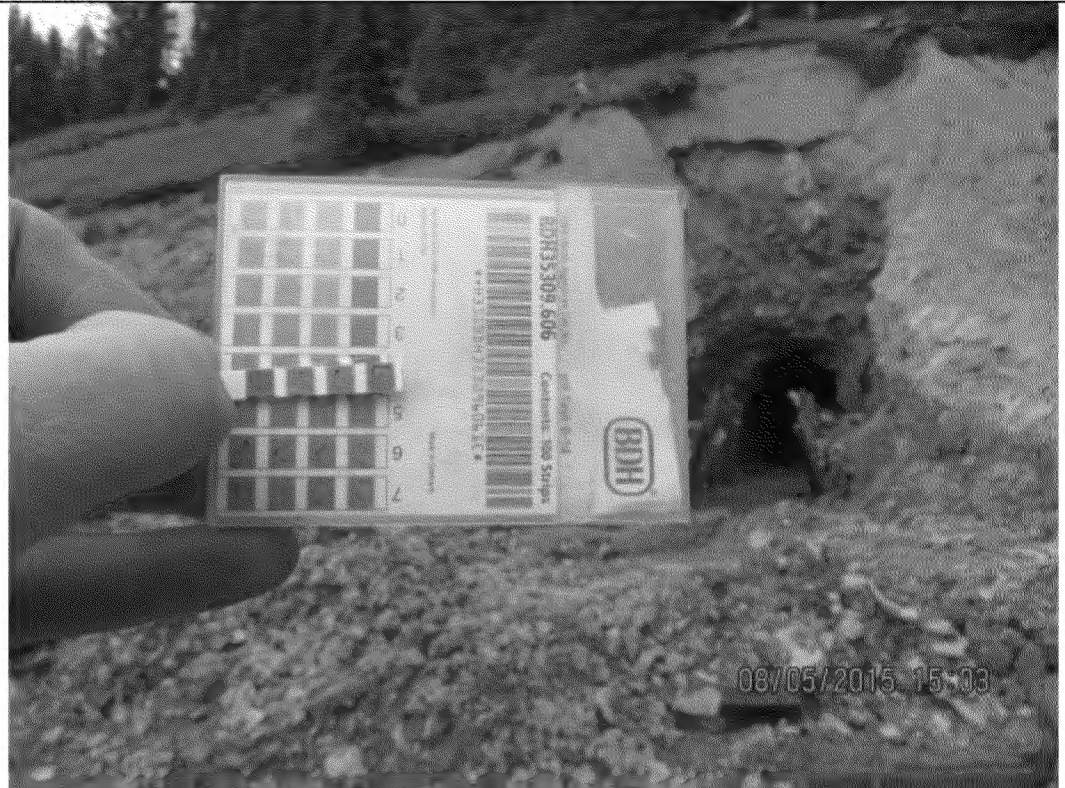
**Photo No.**  
**49**

pH measured at approximately 4.5.

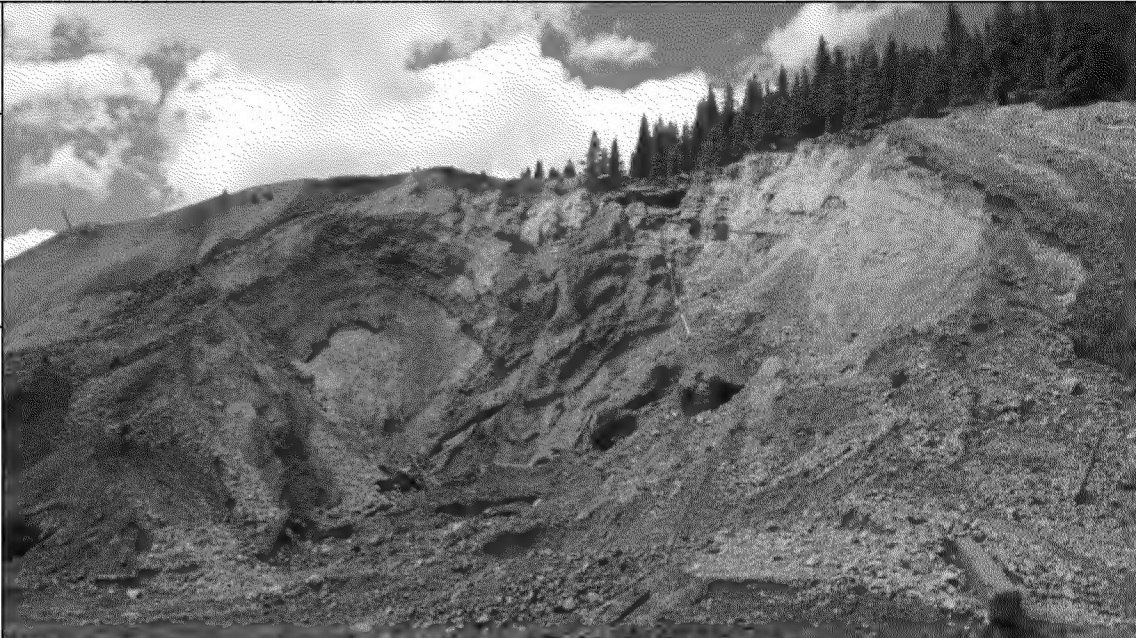
| <b>Photo No.</b><br><b>51</b> | <b>Date:</b><br>08/05/2015 | |

| <b>Description:</b><br>Looking up from the toe of the Gold King waste dump directly south of the adit. | | |

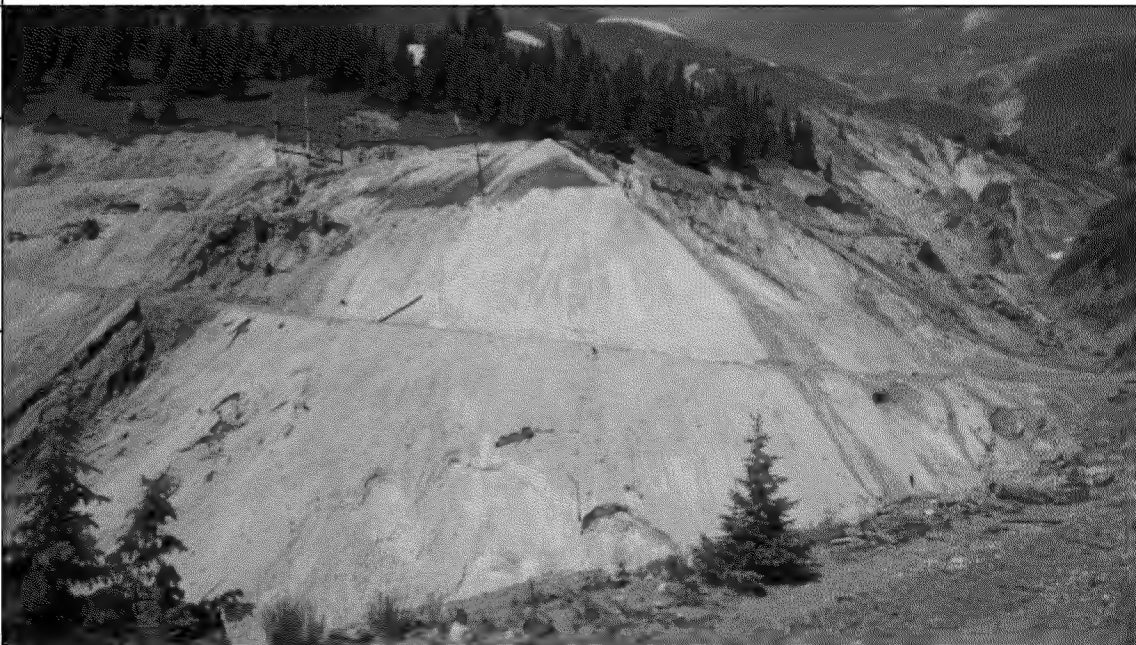
| <b>Photo No.</b><br><b>52</b> | <b>Date:</b><br>08/05/2015 | |

| <b>Description:</b><br>Gold King Mine tailings dump after water discharge. | | |

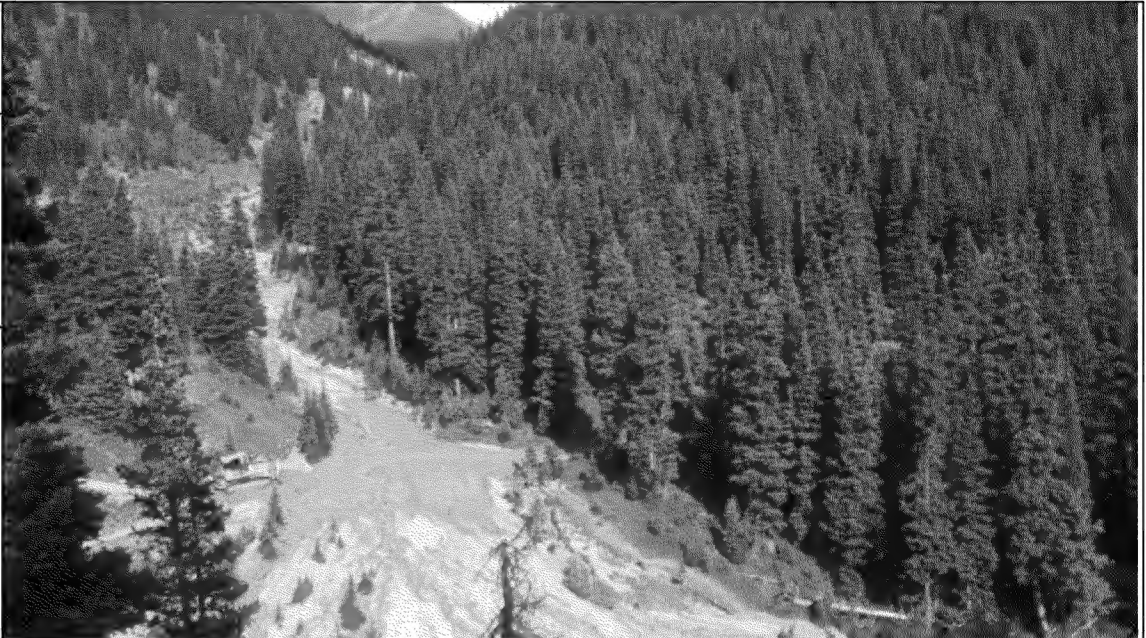
| <b>Photo No.</b><br><b>53</b> | <b>Date:</b><br>08/05/2015 | |

| <b>Description:</b><br><br>Looking east across Cement Creek from County Road 10 to excavator fixing County Road 52 at North Fork crossing just south of Red and Bonita Mine. | | |
